Master Plan Update Improvements to the Hawaiian Islands Humpback Whale National Marine Sanctuary

Kihei, Maui

July 20, 2009, FINAL REPORT

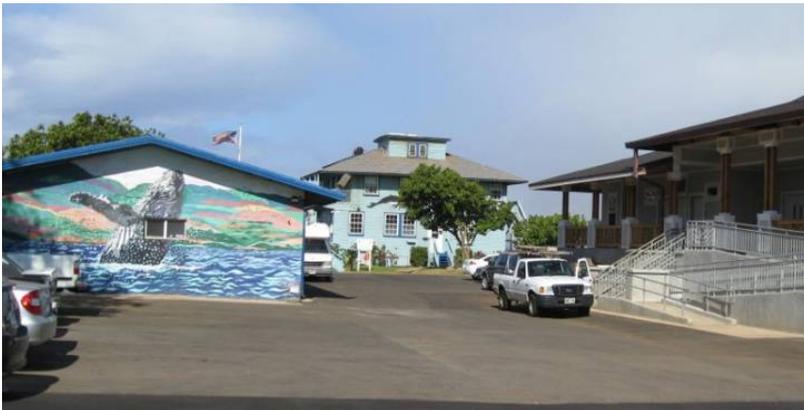
The Sanctuary has a vibrant program of meetings, educational programs and outreach events which draws many visitors. However the site is very small, and during these events parking is extremely limited. The Sanctuary has tried to provide as much on-site parking as possible, but in doing so, has created a “sea of asphalt” on an otherwise picturesque site.

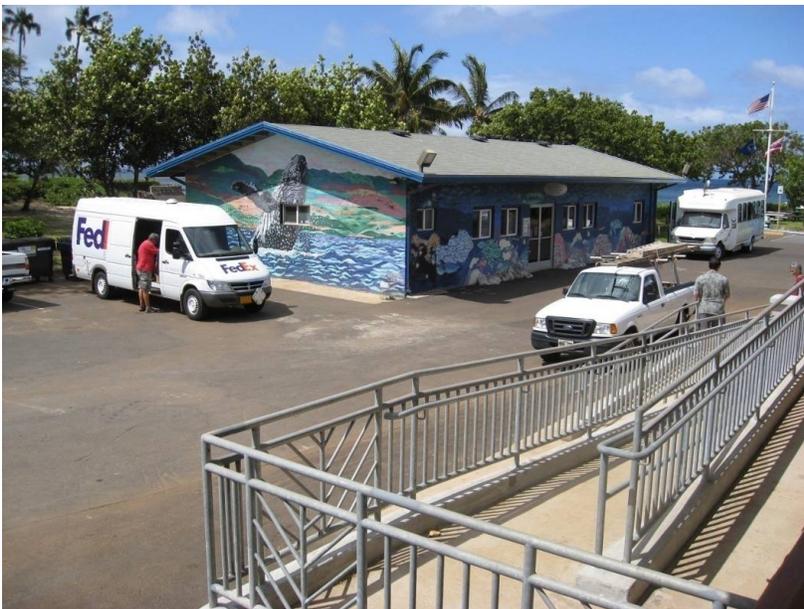
The site lacks any sense of arrival for visitors. After leaving their cars, visitors wander across the asphalt between the New Sanctuary Learning Center and the Masonry Building, often dodging other vehicles.

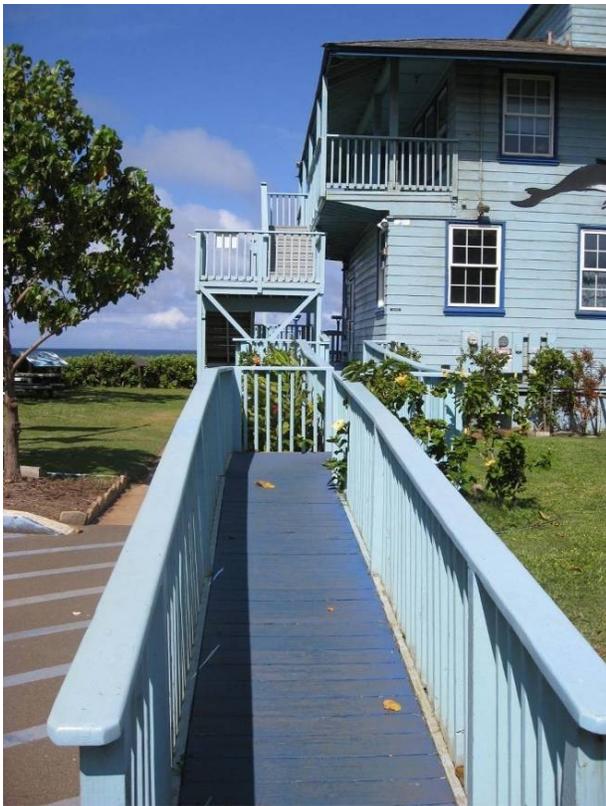
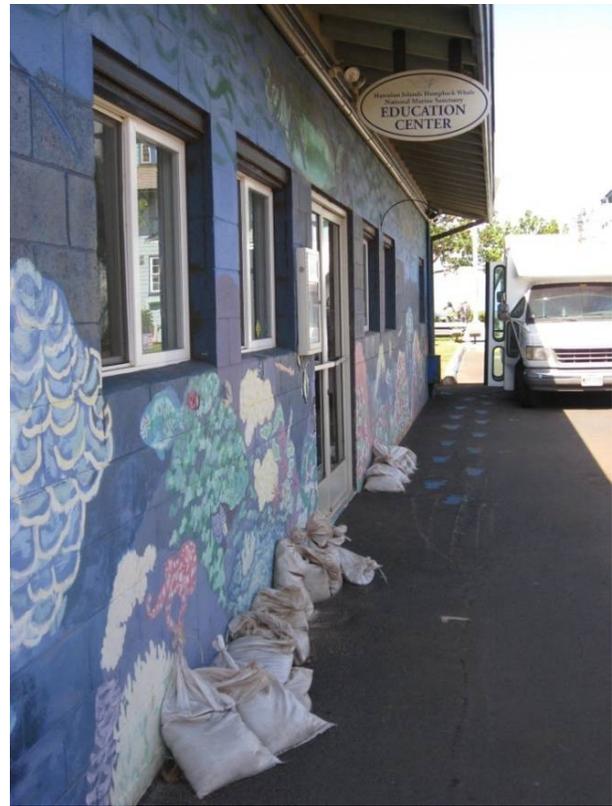
The site lies within the 100 year flood plain and periodically storm water sheets across the property. Both the Main Building and the New Sanctuary Learning Center are elevated structures, but the Masonry Building was constructed with a slab on grade. When the site floods, the Masonry Building also floods. Sanctuary staff keep sandbags near the entry to the Masonry Building.

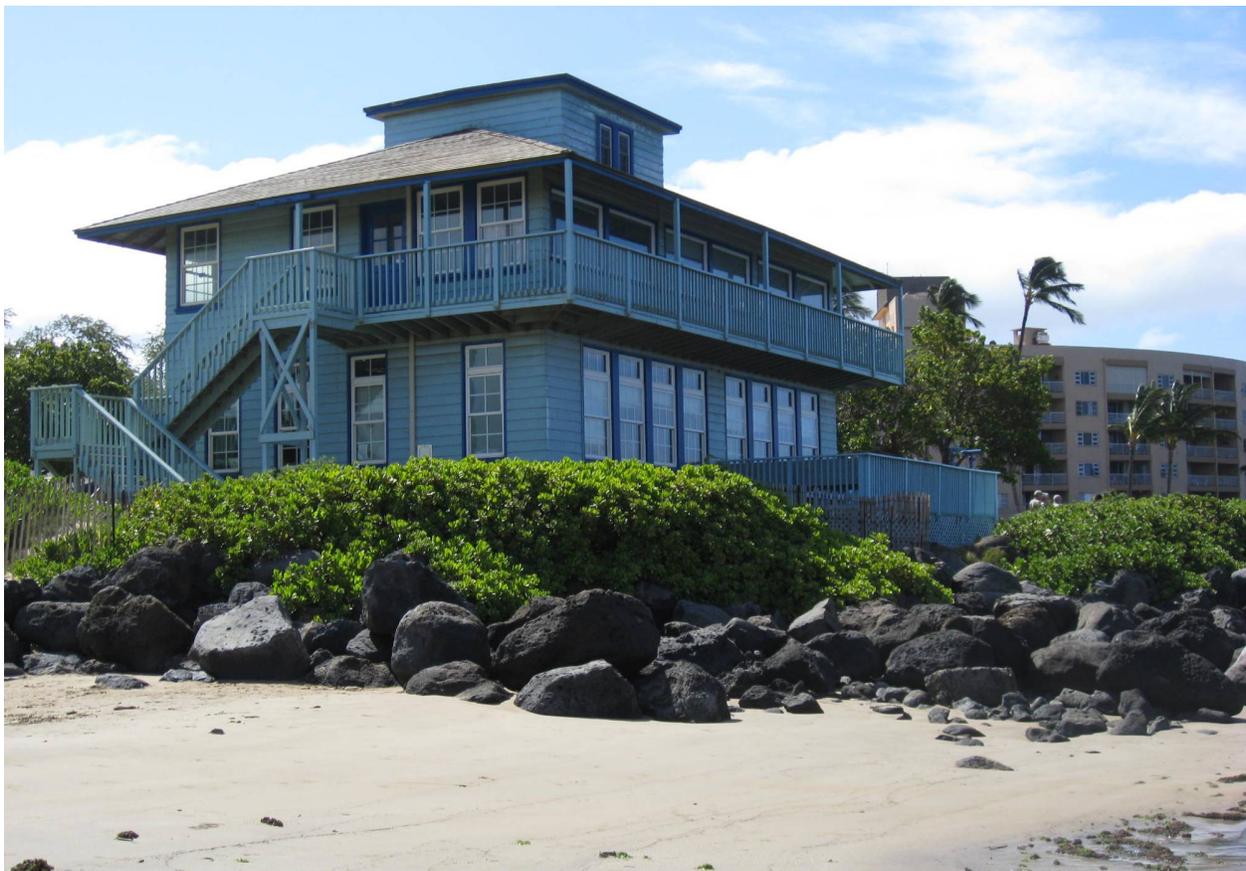
The Main Building is a 60+ year old wooden building that was built during wartime for classified military purposes. It has sat on a promontory, buffeted by weathering effects of the coastal winds and the sea. It is like a classic old house that requires significant, continual, and expensive maintenance.

- Make needed repairs to stabilize the building.
These can best be described as deferred maintenance. They involve making the building weathertight and structurally sound. The exterior should be repaired, caulked and painted. The mold should be abated and the cause of the mold should be eliminated. Any critical structural repairs should be made. Any areas where the roof is leaking should be fixed.

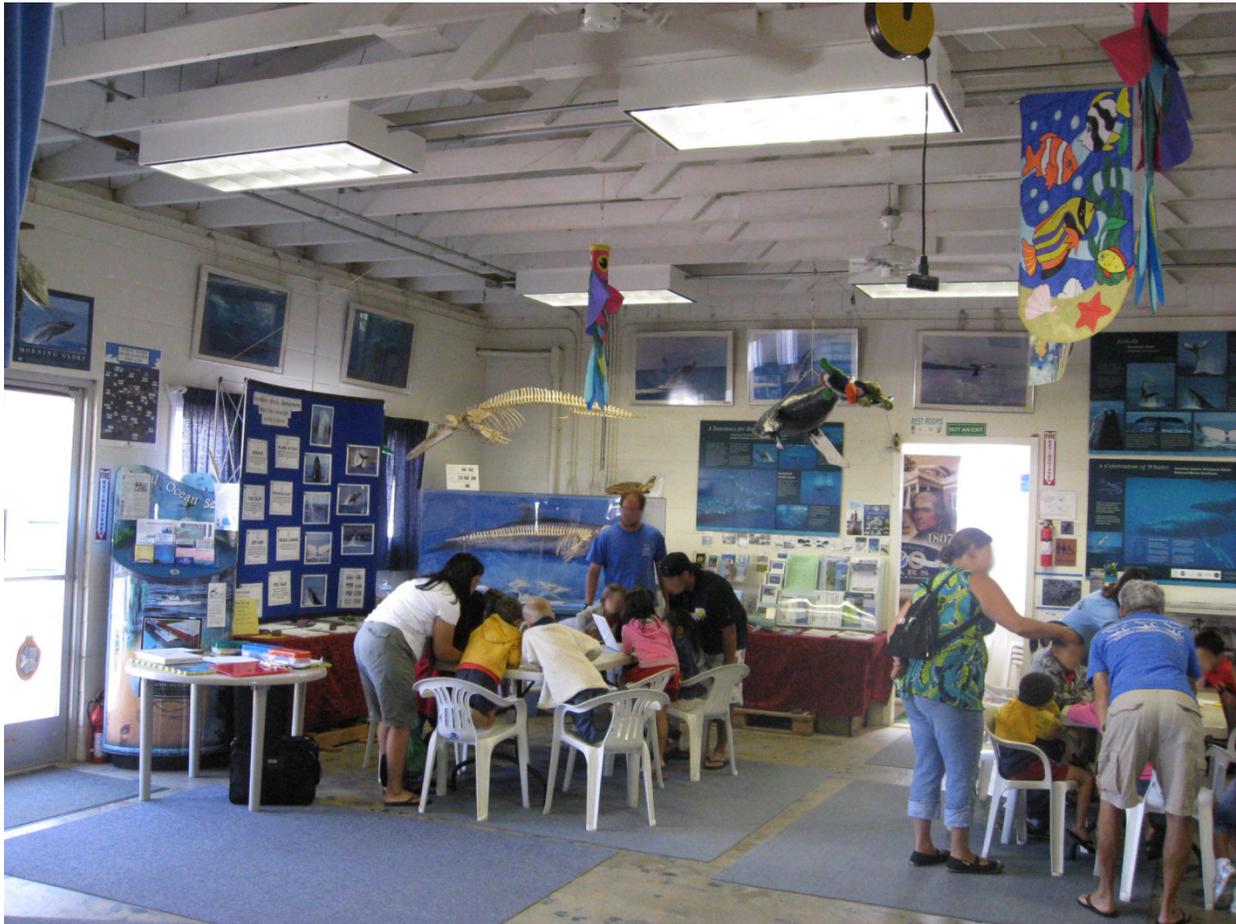
The biggest drawback facing this building is that the elevation of the floor slab is within the 100 year flood plain, and the building periodically floods—a problem that needs to be addressed.

- Re-grade the site around the Masonry Building.
As part of the project to help the Masonry Building withstand flooding, the ground area around the Masonry Building should be raised slightly so that water drains away from the building. This will require treating the bottom 12" to 18" of the building wall as a waterproof barrier, so no moisture can permeate inside.
- Expand the lawn area next to the Main Building.
There is a grassy area with picnic tables to the south of the Main Building. This area should be expanded toward the new plaza, with additional shade trees and wind breaks.
- Install signage and kiosks to present the cultural resources and history of the site.
As mentioned above, the new plaza and surrounding lawn are an opportunity to explain the significance of this site, and tell the story of the peoples who came before.
