ARCHAEOLOGICAL SURVEY AND IDENTIFICATION OF
USS *CONESTOGA* (AT 54) OFF SOUTHEAST FARALLON ISLAND
GREATER FARALLONES NATIONAL MARINE SANCTUARY
MARITIME HERITAGE ASSESSMENT EXPEDITION
SEPTEMBER 2014 - OCTOBER 2015

**James P. Delgado and Robert V. Schwemmer, Co-Principal Investigators
Maritime Heritage Program, NOAA's Office of National Marine Sanctuaries
January 2016**

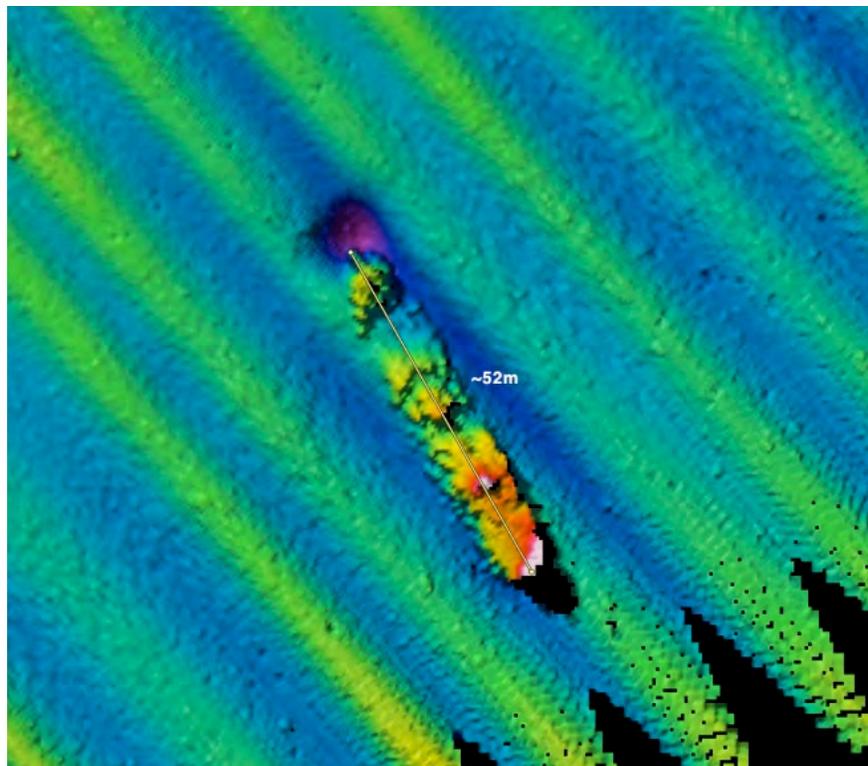
Additional processing of the multibeam sonar data estimated the wreck to be 52 meters (167 feet) in length with a beam of 8-9 meters or nearly 30 feet (Fig. 3). The hull rises 4.5 meters (15 feet) off the seabed at both bow and stern as measured by the ROV (The NOAA/Fugro report from the 2009 survey reported target relief at 5 meters). Approximately 1-2 meters (3-1/2 to 7 feet) of hull is embedded in the sediments that surround it. The wreck is more or less on a level keel, with a slight list to port. The seabed in this area is characterized by mixed substrates of sand and silt, with occasional rock outcrops. The seabed immediately surrounding the wreck is a coarse to fine sand/silt mix.

Fig. 3: Multibeam image of Southeast Farallon Island target from Survey H11965 with additional processing and measurement estimates by Gary Fabian.

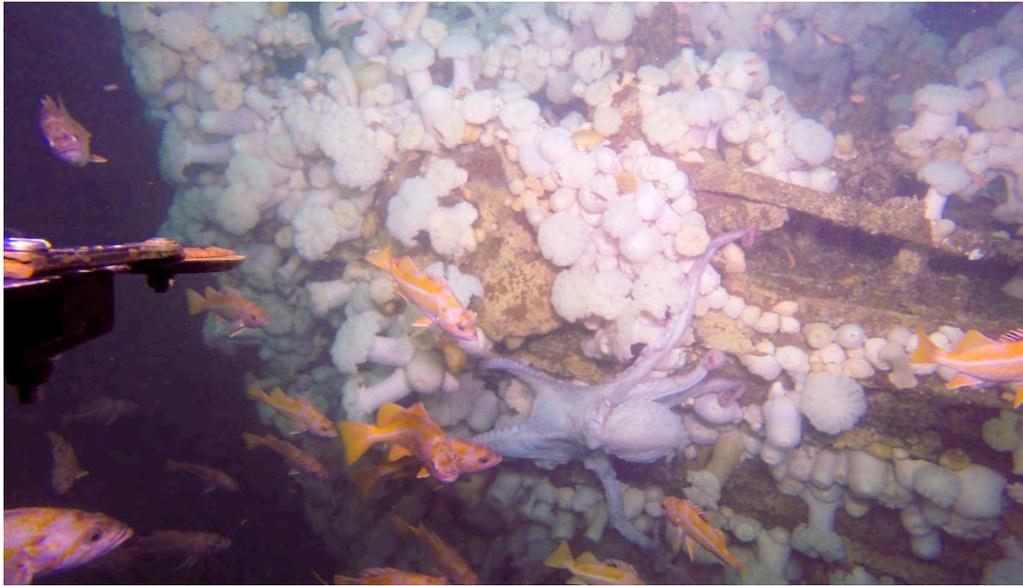
Fig. 4: Port bow of the wreck, showing the rub rail mounts, a hawse hole, marine growth and an octopus

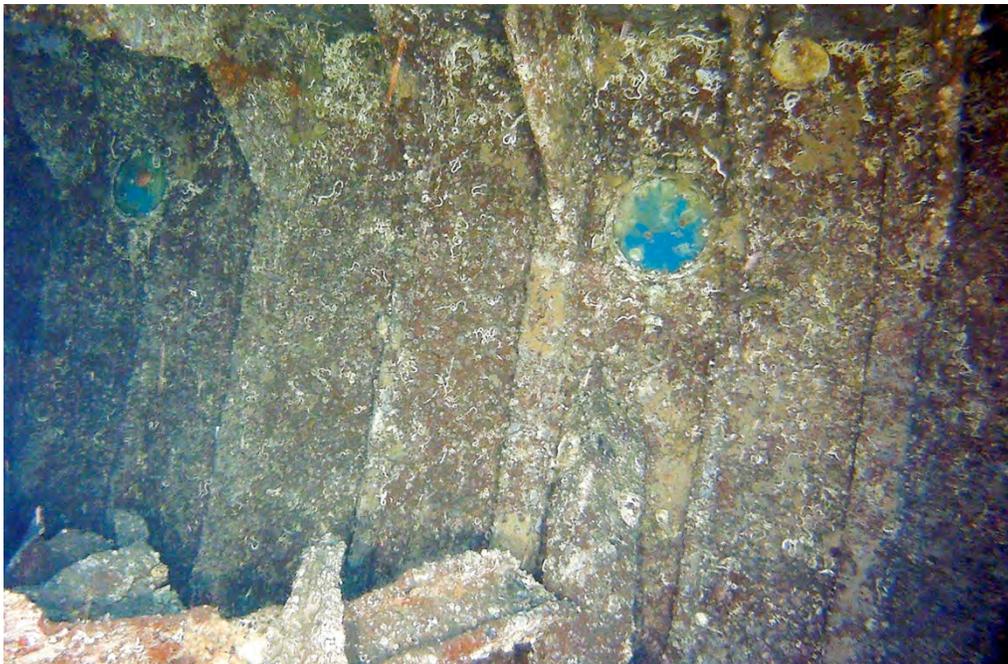
However, portholes are present, with glass intact in the deadlights, at the bow. Penetration of the forecastle with a small ROV in 2015 documented five ports on each beam of the hull that illuminate this compartment (see Fig.5).

Fig. 5: Interior of the forecastle, starboard beam, showing portholes

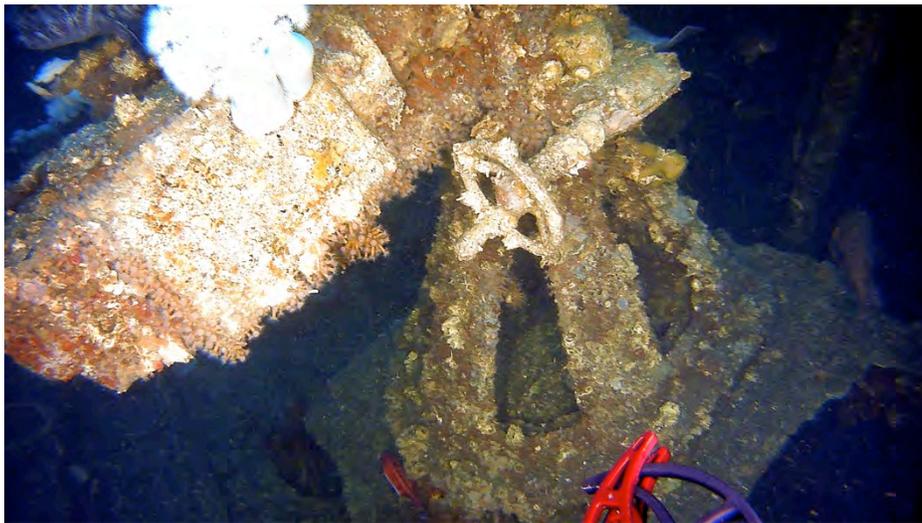
In the forward opening below the main deck, three significant and diagnostic features were observed. The first, sitting upright immediately aft of the anchor windlass is a single naval gun, which from its form and estimated dimensions, as well as its mount, is a U.S. Navy 3-inch/50 caliber single purpose gun on a WWI-era mount. Based on its position, this gun has fallen into the hull through the main deck. The gun retains its spotting telescopes (Fig. 6).

Fig. 6: 3-inch/50 caliber gun lying inside the forward hull

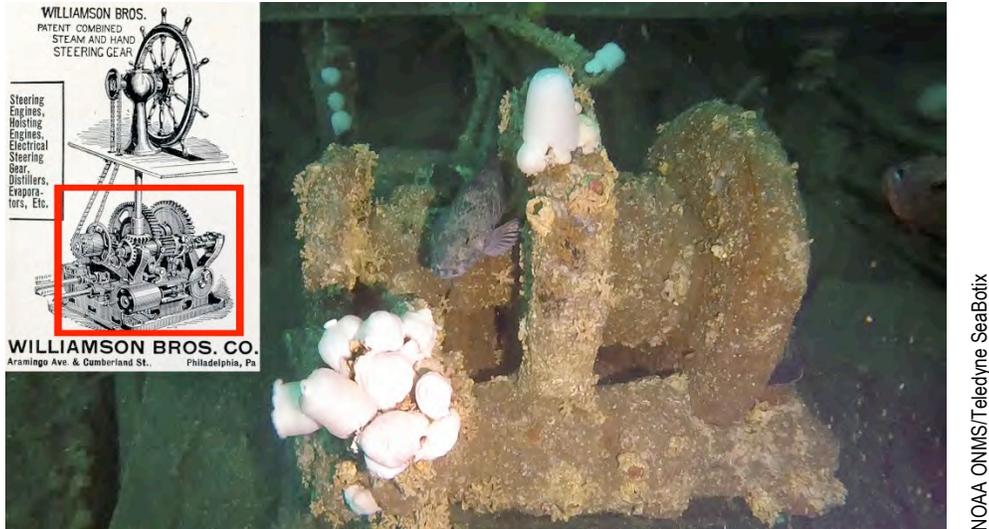
The second feature, aft of the gun, is a steam steering engine of the Williamson Brothers patent type (Fig. 7). The engine is missing its steering chains or cable. It is displaced

from its original position, and like the adjacent gun, appears to have fallen into the hull as the superstructure above disintegrated.

Fig. 7: Williamson Brothers patent combined steam and hand steering gear, lying inside the forward hull next to the 3-inch/50 caliber gun.

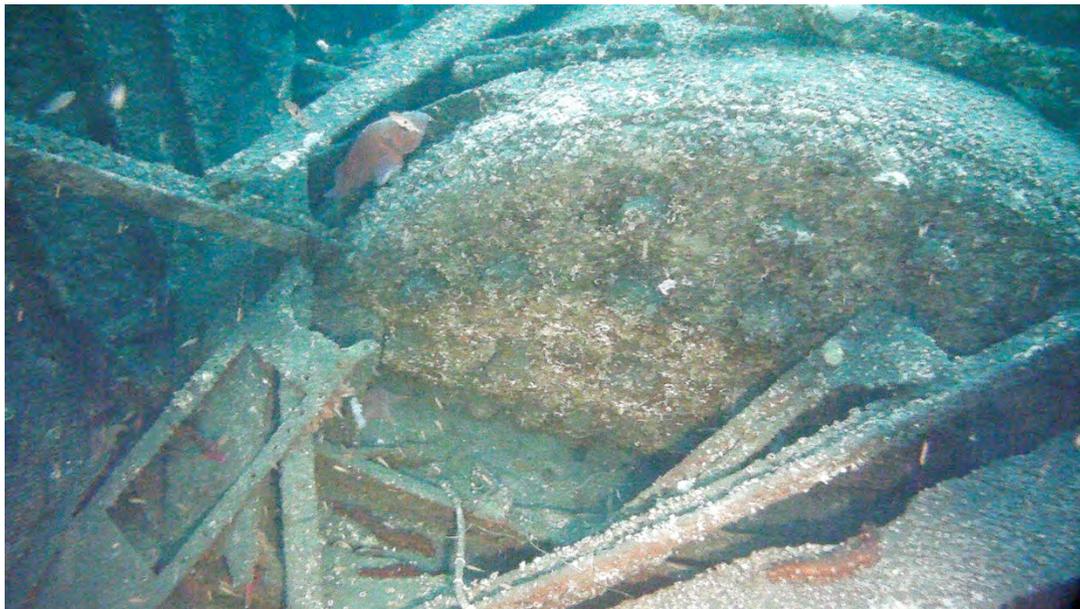
The third feature(s) are two closely spaced Scotch marine boilers, side by side, spanning the breadth of the hull (Fig. 8). The boilers are coal-fired, and aft of their compartment is the coal bunker, which is partially filled with what appears to be anthracite coal. The associated piping, including the main steam line is intact and run aft into the engine room.

Fig. 8: Inside the boiler compartment, showing part of one boiler and collapsed debris from the upper works of the tug

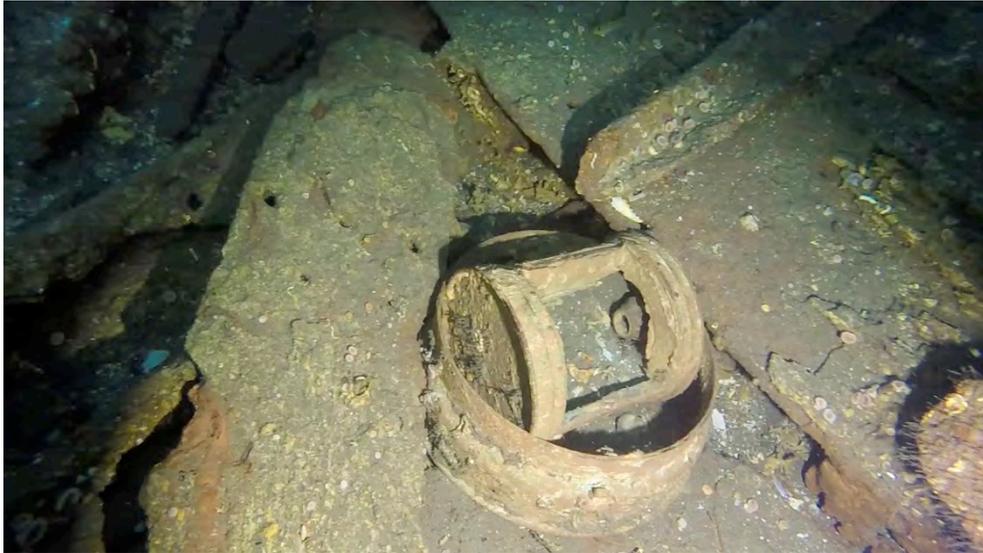
Also, lying inside the hull on the port and starboard sides are a pair of mooring bitts just forward of the boilers. These appear to have fallen in as the deck collapsed. Close to the gun is an electric running light, presumably from the wooden foremast, and metal mast deck collar which have fallen into the forward hull with a variety of steel plate and frames from the disintegrated superstructure (Fig. 9).

Fig. 9: Foremast electric running light inside the forward area of the hull, where it appears to have fallen as the superstructure and masts disintegrated and collapsed

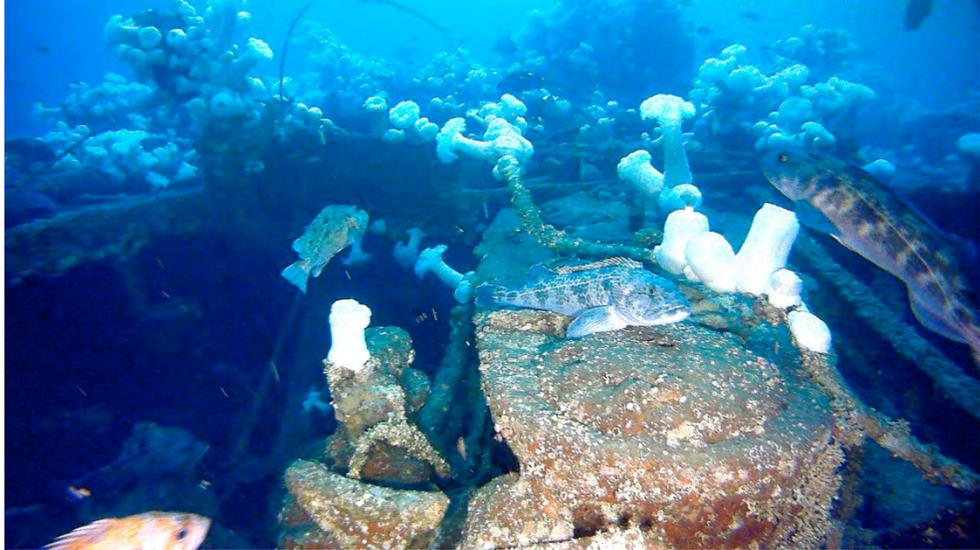
The fourth significant feature observed in the engine room is the tug’s triple expansion marine steam engine. The engine is intact and remains mounted in position (Fig. 10). The

cylinder heads are intact with no evidence of cracking or any other damage to the main body of the engine.

Fig. 10: The engineering spaces lie below the triple-expansion marine steam engine, as shown here in this view looking towards the stern. Loose debris from the superstructure and deck cover the top of the engine's low compression cylinder.

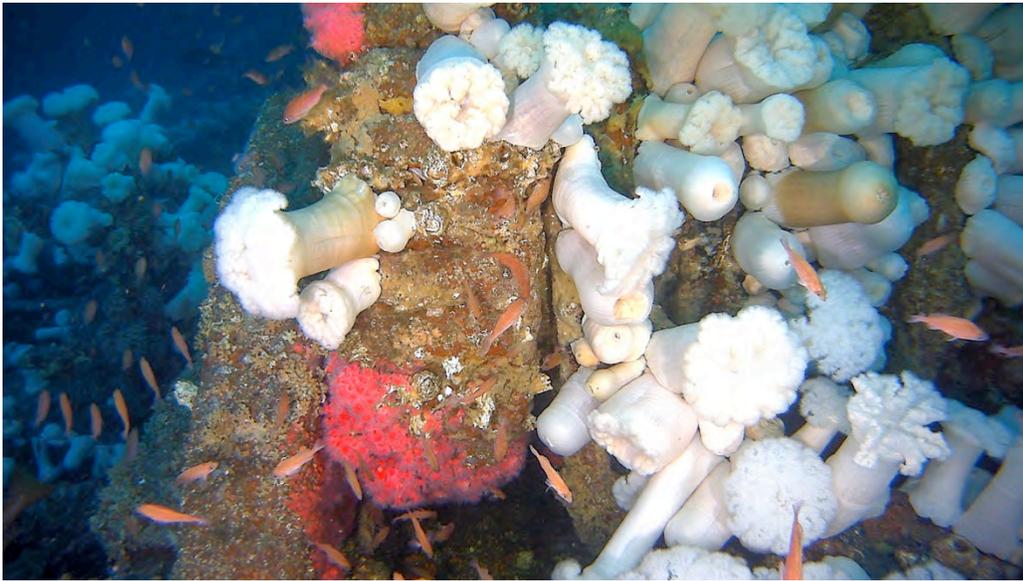
Aft of the steam engine, the deck resumes as a steel or iron plated surface. A large steam-towing winch (also known as a “towing engine”) is situated amidships (Fig. 11). The drum is wrapped with steel cable, which terminates in a wire loop. The wire is not neatly wrapped, and it appears to have “spooled” as if quickly hauled in. Stowed aft and below the winch is possibly a tow shackle.

Fig. 11: The steam towing winch or “towing engine” on the aft deck

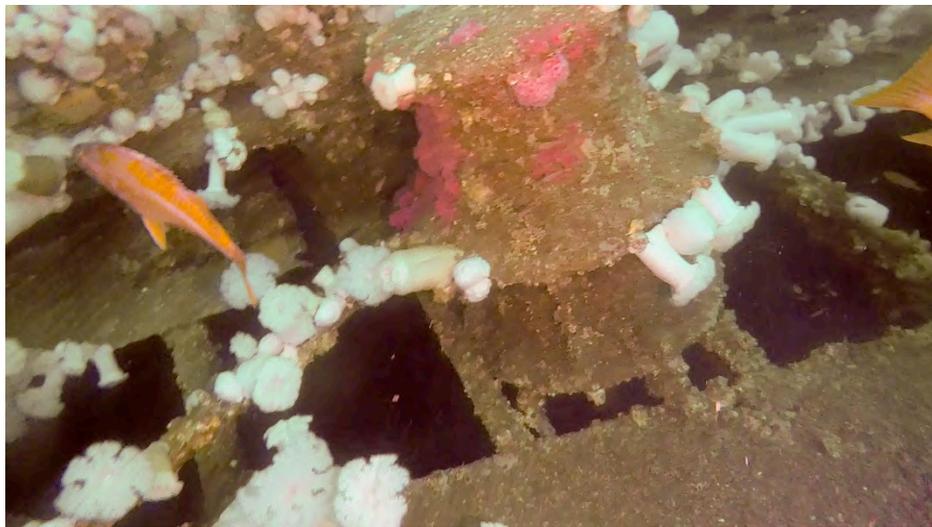
Two large mooring bitts are mounted to the deck on either side of the towing winch; to starboard a substantial steam gypsy is positioned in place and near the bulwark and mooring bitts (Fig. 12). This piece of machinery was used to handle tackle such as mooring lines.

Fig. 12: Steam gypsy mounted on the deck to the starboard beam of the towing winch

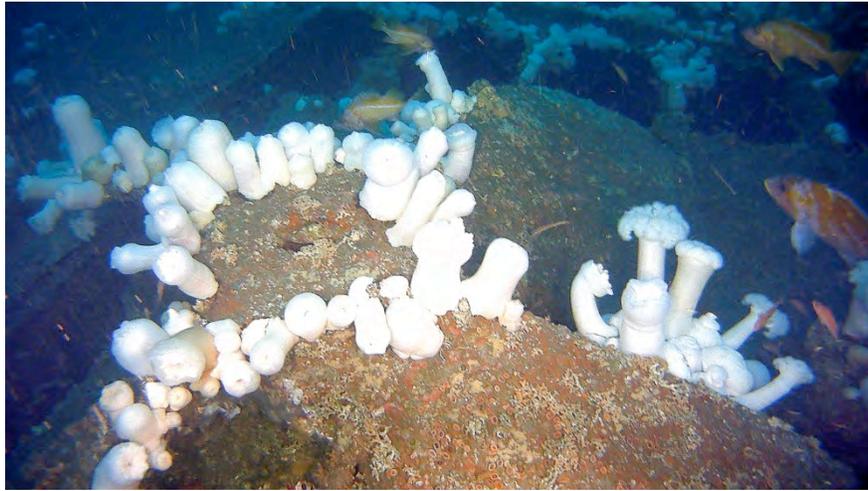
Aft of the towing winch, the deck is metal and clear except for four openings, which from their position appear to be the round base mounts for the port and starboard ventilators, square holes for the wooden towing bitts that are no longer visible. Just aft of the openings is a four-bladed iron or steel propeller stowed on deck; this was a spare (Fig. 13).

Fig. 13: Spare propeller on the deck aft of the towing winch

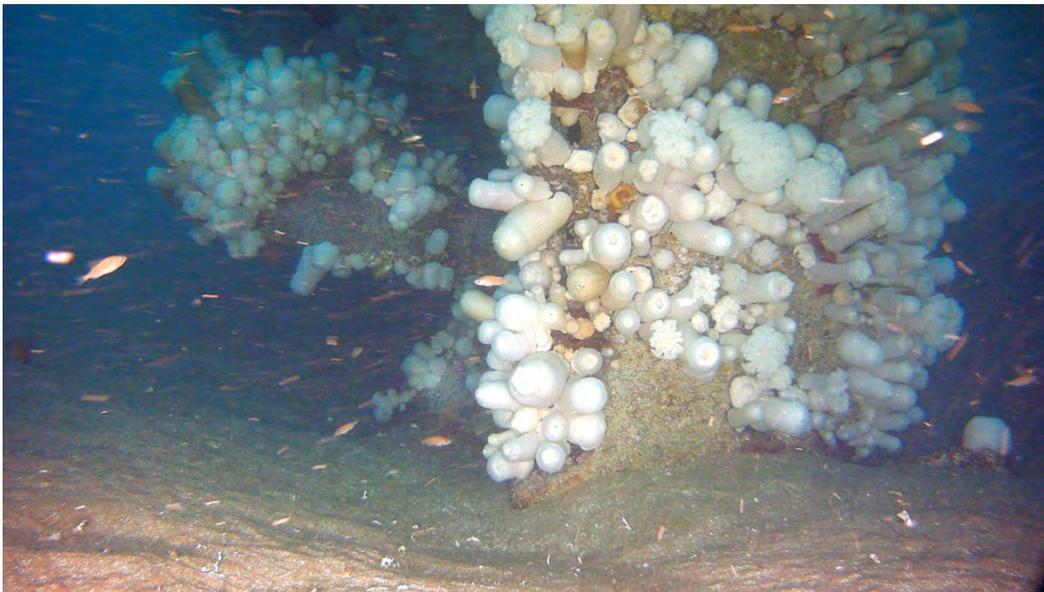
The head of the rudder shaft is mounted to the rudder, which as the quadrant's position indicates, is sharply turned to starboard at least a 90-degree angle. The propeller, a four-bladed screw of substantial size, with each blade roughly measuring nearly a meter and half or more (suggesting an original "wheel" or screw diameter of three or more meters), is in place, with the lower blades partially buried in the sediment (Fig. 14).

Fig. 14: The rudder and two of the propeller blades at the stern port side of the rudder, one partially buried in the seabed

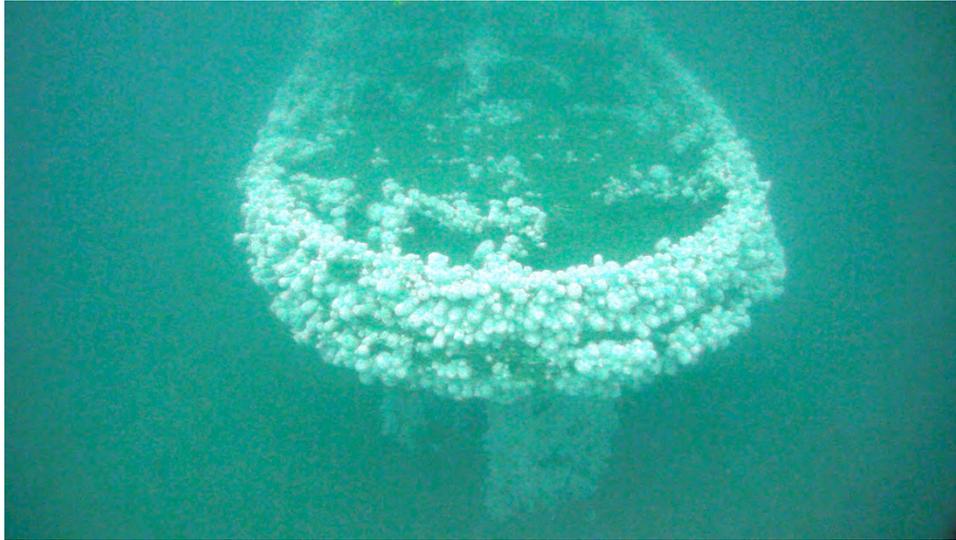
As previously noted, the wreck is heavily draped in a variety of invertebrate growth. The fantail, however, was carefully examined in 2015, and raised metal letters spelling part of the vessel's name were documented. The outline form of what appears to be the leg of the letter "T" with an adjacent letter "O" was observed through the marine growth (Fig. 15 and Fig. 26).

Fig. 15: The stern of the wreck, showing the heavy marine growth and the position of the rudder hard to starboard and steering quadrant on deck hard to port

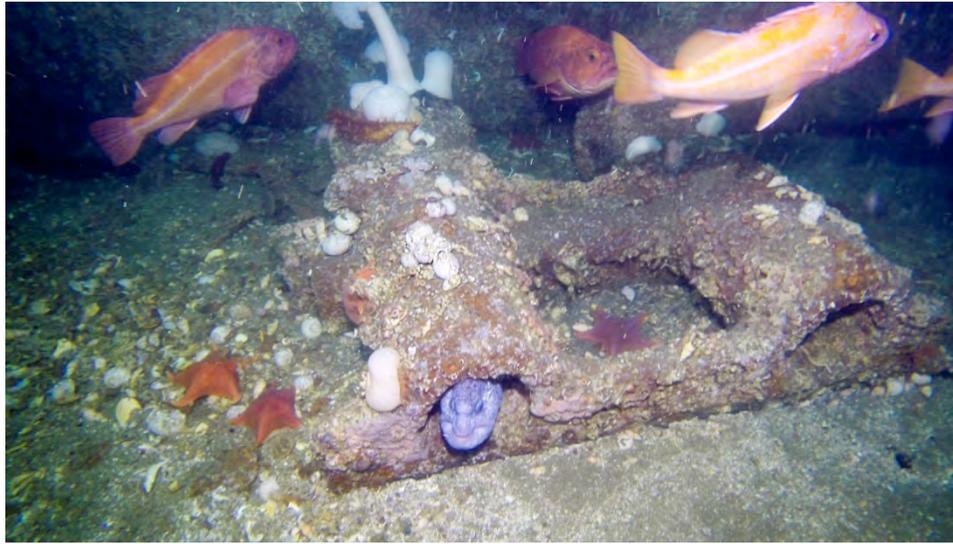
There was no netting observed on the wreck; two sections of rope or line were caught on the structure, and two crab pots of undetermined age were observed lying close to the starboard bow. Lying on the seabed at parallel locations, both off the starboard and port beam are detached mooring bitts, as well as loose, light-gauge riveted plate (Fig. 16). On the starboard side on the seabed is a rectangular frame, possibly one of the window frames.

Fig. 16: A detached mooring bitt lying on the seabed next to the wreck

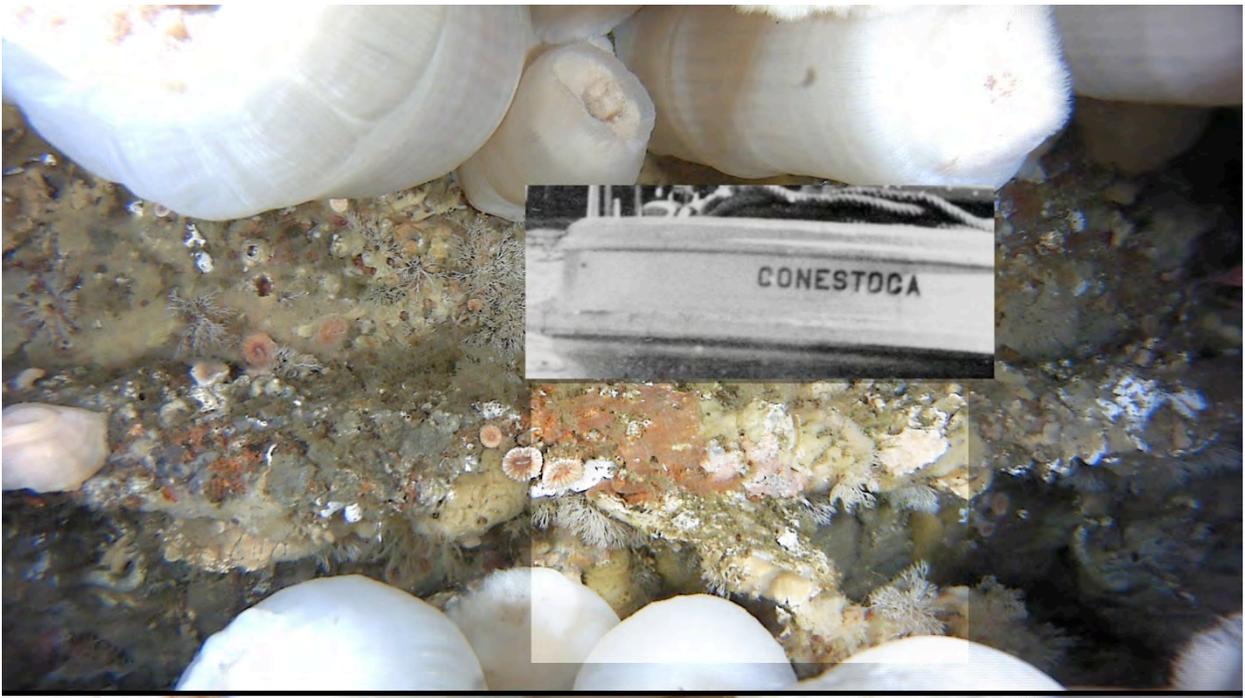
- The condition of the tug in addition to the gun indicates it was active, and operating when lost. It was not scuttled. The anchor, spare propeller, all of the machinery, especially the gun with its spotting telescopes, are not items to be left behind on a discarded ship.
- While corrosion and marine growth have obscured the fantail, careful observation showed what appear to be part of the “T” and the “O” of *Conestoga*’s name on the fantail (Fig. 26).

Fig. 26: Probable letters on fantail from the vessel's name
