August 27, 2015

MEMORANDUM

SUBJECT: Site Characterization USNS *Mission San Miguel*

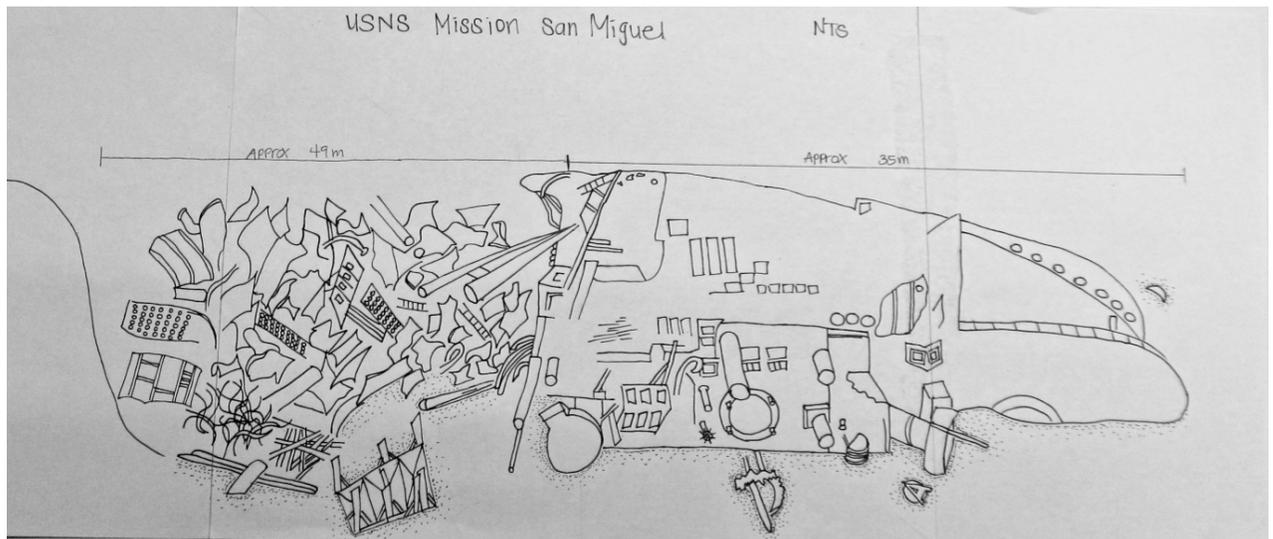
Figure 1: Mud Map of USNS *Mission San Miguel* (Rebecca Weible)

The wreck lies at a bearing of 080° and consists of three main sections. These include the largely intact stern section of the ship, which rests on its port side and rises from approximately 24 m (80 feet) at the seabed to a depth of 8.8 m (29 feet) below the water surface; the aft cargo tank section, which is located directly forward of the stern and is mostly collapsed; and an area thought to represent the tanker's bow located approximately 165 m (540 feet) east and northeast of the stern section and includes two anchors and chain, numerous components of deck machinery, and scattered sections of hull plate and piping in depths ranging from 1.5 to 10.5 m (5 to 35 feet). Each of these aspects of the vessel's deposition closely matches historical data pertaining to the USNS *Mission San Miguel*. According to the US Navy reports, when salvage operations were terminated the 160m (524 foot) long tanker was aground with a bearing of 075° and drew four feet in the forward part and 83 feet in the after portion (Raupp et. al. 2015).

In reviewing the data from the August 3-4 survey, it is apparent that the disintegration of the majority of the hull of the vessel extends to the engineering spaces in the stern. As the vessel sank and moved deeper, it is likely that the vessel twisted and broke apart. The bow, being the most shallow portion of the wreck, has collapsed and broken apart. Only the stern is intact. Structural collapse of all but approximately 100 feet of the 558 foot hull includes the fuel oil tank on the starboard side of the stern. About 18 feet of the port side and therefore the port fuel oil tank is buried in the sand bottom. The archaeological team believes that, while this tank may not be collapsed, it may have opened up to some extent due to the pressure of the wreck. They observed no oil or sheening on the site. Divers did not enter the wreck but visible overhead spaces did not contain any obvious oil (Raupp et.al. 2015).

The only other archaeological work that could be undertaken would be excavation of the buried port tank area but that is not recommended. The existence of oil residue or trapped oil beneath portions of the intact stern is possible, but we believe the amounts would be minimal.
