## Shipwreck MV *Fernstream* - First Three-Dimensional Sonar Site Assessment Survey

### First 3-D Sonar Site Assessment Survey

Working with the San Francisco Police Department's Marine Unit, Coda Octopus conducted an Echoscope 3-D sonar survey of the shipwreck MV *Fernstream* in 2013.

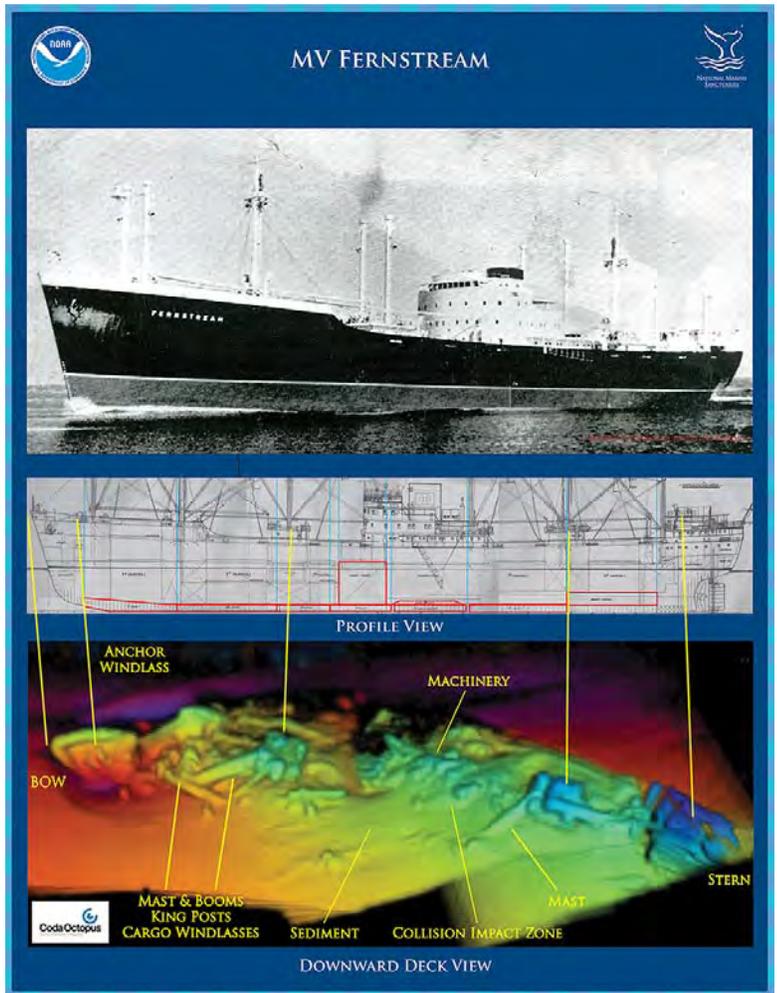
Confirmed by the 3-D sonar survey and mapping, the shipwreck *Fernstream* sits upright with the fore-castle, partial remains of the stern-house and bridge-house, as well as the forward and after mast house structures are all visible. The hull has suffered from catastrophic collapse of the bridge-house structure; there is a severe breach in the steel hull on the starboard side forward of the bridge-house; masts, booms, and king posts have all collapsed onto the main deck

or possibly shelter deck; and the port side of the wreck is buried deep in sediment. The stern is the highest remaining structure above seafloor, but also in a state of collapse. The shipwreck appears to be listing to port in the bow. At the starboard breach in the hull, forward of the bridge-house structure, the bow is no longer in longitudinal alignment with the after part of the hull. Outside the wreck, the starboard side of the hull shows evidence of sediment scouring, more prominently in the bow, a typical occurrence with shipwrecks due to their position on the seafloor in prevailing currents.

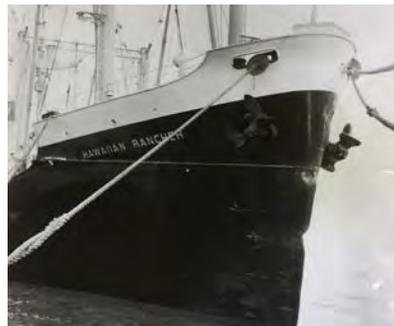
SS *Hawaiian Rancher* with bow damage after the collision with MV *Fernstream*.

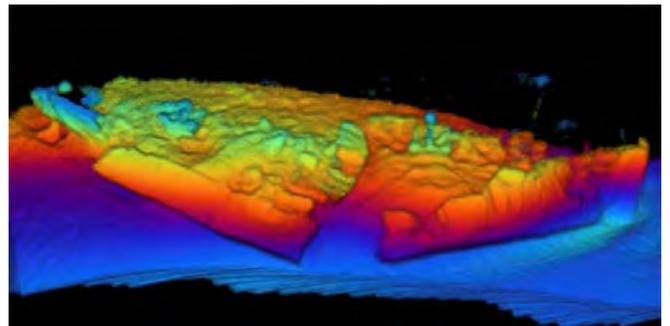
Coda Octopus 3-D image of the shipwreck MV *Fernstream* with a severe breach in the starboard hull forward of the bridge-house.
